**TRAFFIC STUDY
FOR
SR 20/CONYERS ROAD AT
HUNTINGTON DRIVE**

Loganville, GA
Walton County

Prepared for
City of Loganville, GA in Association with
Keck & Wood, Inc.

W & A Project No. 16-TF-023

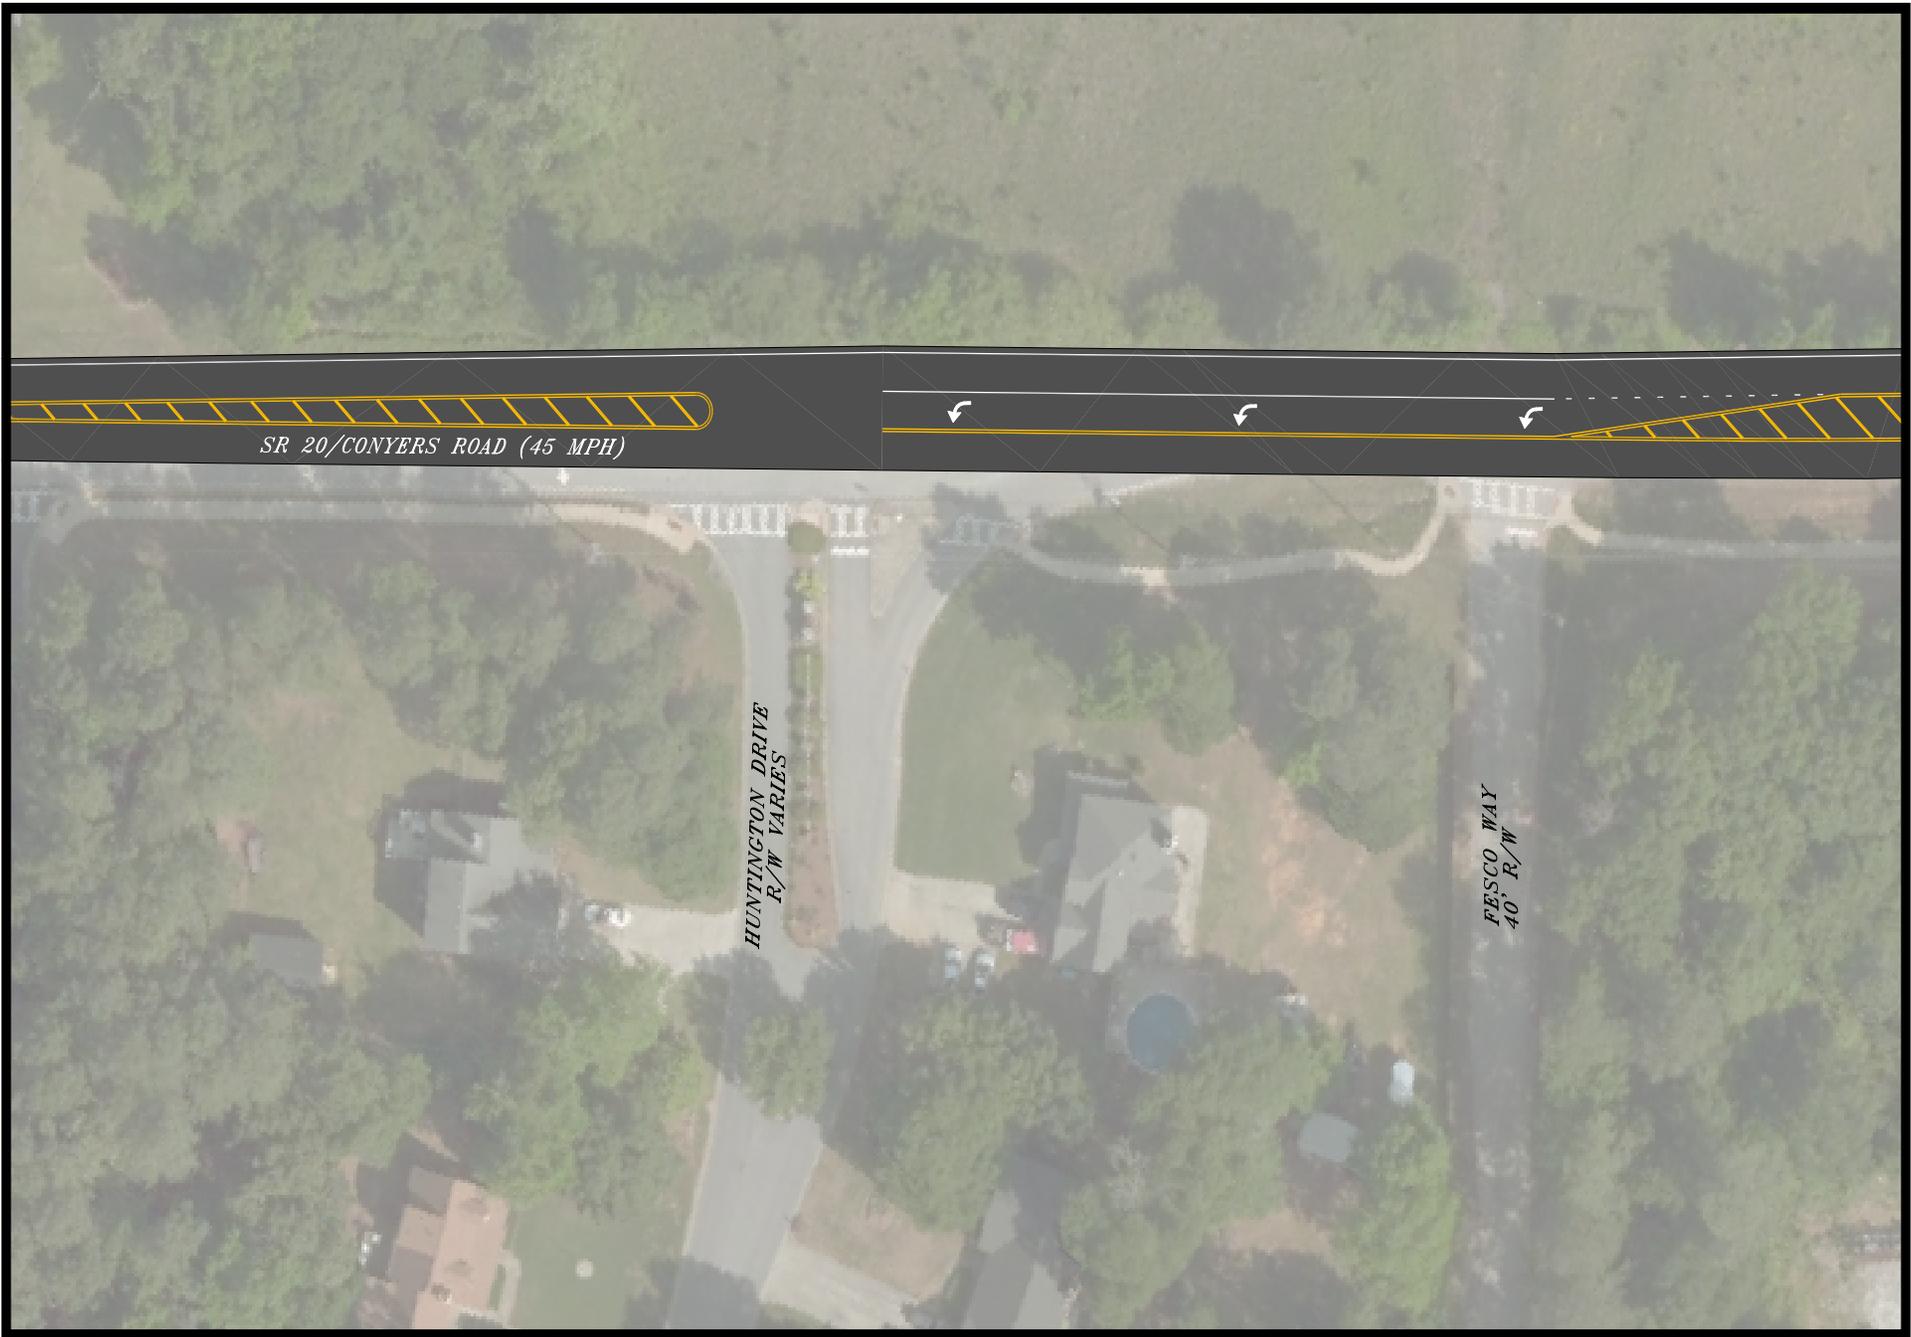
ALTERNATIVE 1
SR 20 / CONYERS ROAD AT HUNTINGTON DRIVE

- Alternative 1: Add westbound left turn lane.
- Alternative 2: Add westbound left turn lane with short TWLTL on SR 20/Conyers Road to the west.

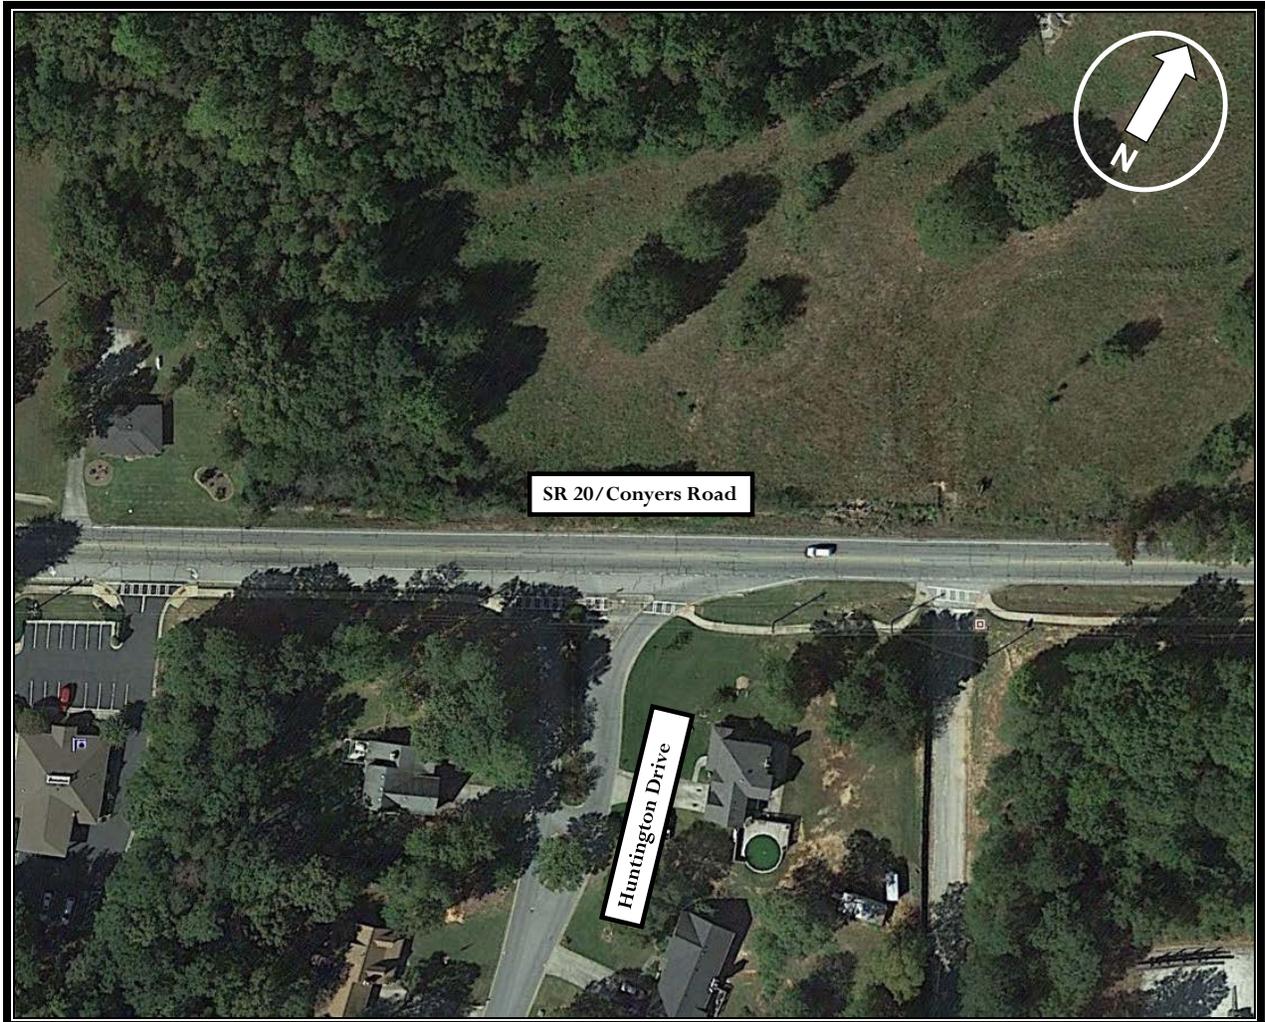
Figure 2 – Study Intersection

This traffic study was conducted to evaluate the operational performance of the intersection of SR 20/Conyers Road at Huntington Drive in Loganville, Walton County, Georgia. Figure 1 illustrates the location of the intersection and identifies the roadway network in the vicinity. Figure 2 shows the study intersection.

The northbound approach leg of Huntington Drive has a left turn lane and a yield-controlled channelized right turn lane. The eastbound approach leg of SR 20/Conyers Road has a through lane and a right turn lane. The westbound approach leg of SR 20/Conyers Road has a shared left+through lane.

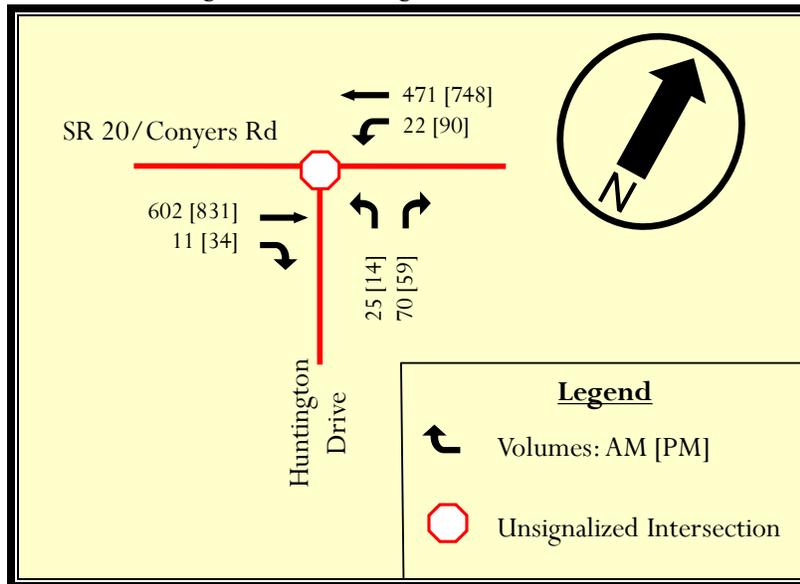
Figure 3 – Existing Peak Hour Volumes

A weekday AM and PM peak period turning movement count (TMC) was taken at the intersection of SR 20/Conyers Road at Huntington Drive on Tuesday, June 21, 2016. According to GDOT's seasonal traffic count factors, June volumes are higher than the average month for a rural major arterial, so no adjustments were made to the raw traffic counts. Traffic counts can be seen in Appendix A. TMC's were taken between 6:30 AM and 8:30 AM during the AM peak period and were taken between 4:00 PM and 6:00 PM during the PM peak period. The peak hour during the AM peak period occurred between 7:30 AM and 8:30 AM. The peak hour during the PM peak period occurred between 5:00 PM and 6:00 PM. The peak hour volumes in the AM and PM peak periods are shown in Figure 2.

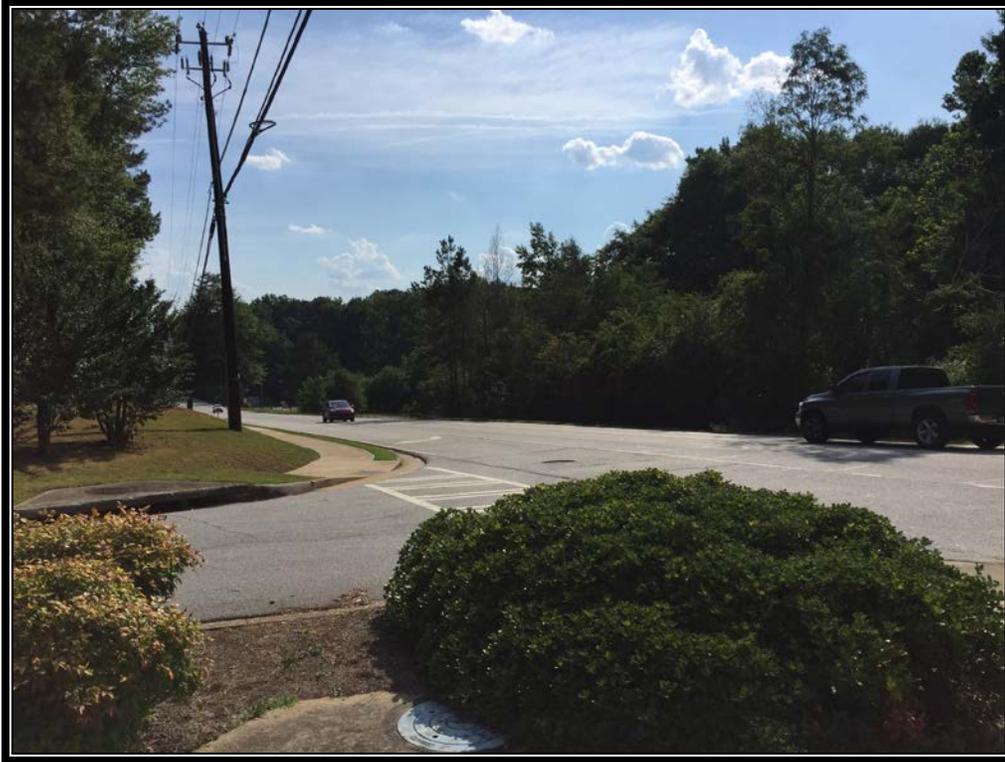
Figure 4 – Sight Distance: Looking West on SR 20/Conyers Road

Figure 4 shows the sight distance for a vehicle at the stop bar on Huntington Drive looking west on SR 20/Conyers Road. Figure 5 shows the sight distance for a vehicle at the stop bar on Huntington Drive looking east on SR 20/Conyers Road.

As seen in Table 1, the required sight distance is 500 feet for a two-lane facility. The sight distance to the northeast and southwest of the project intersection are both greater than 500 feet. They exceed the 500 feet requirement, and therefore are both considered adequate.

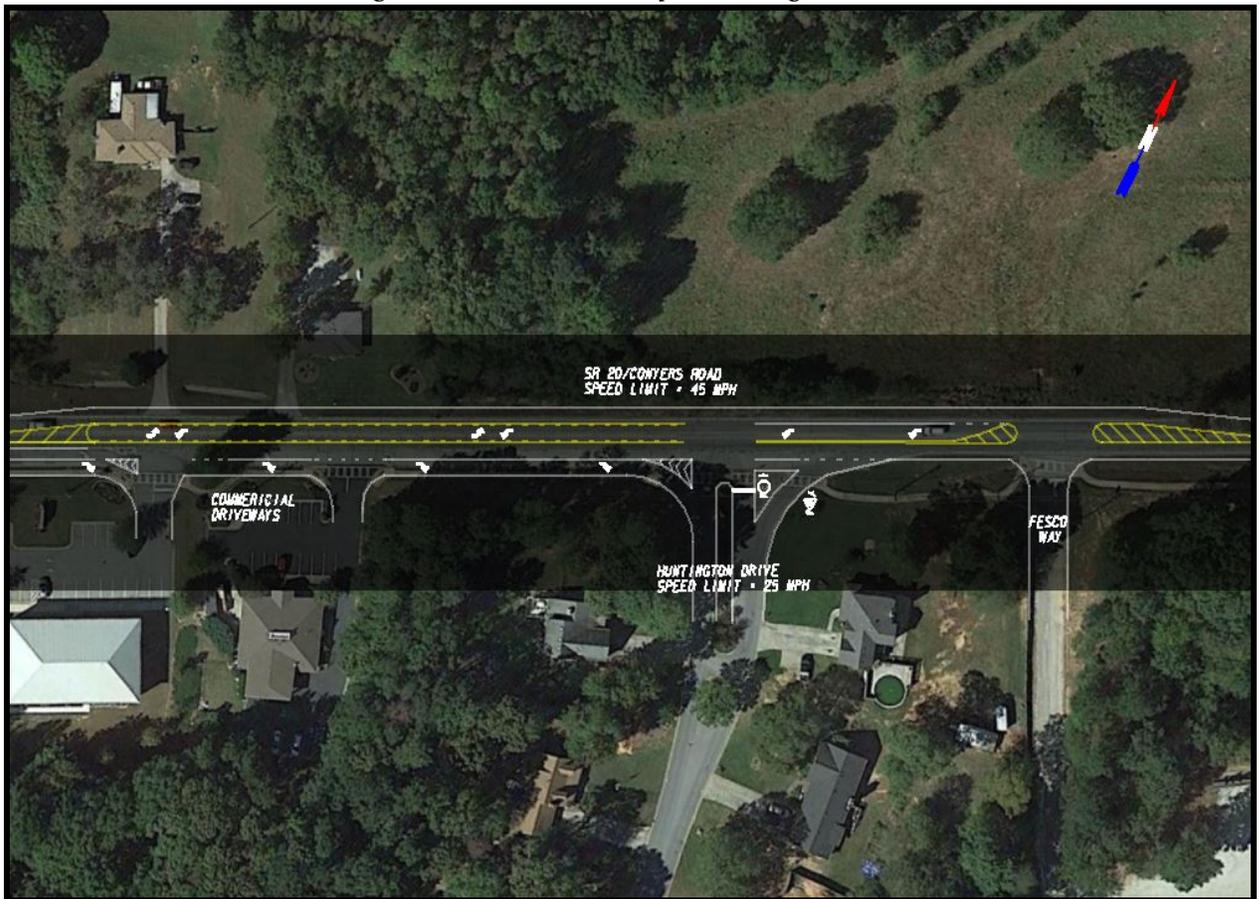
Figure 6 – TWLTL Concept Drawing

Figure 6 shows a concept drawing of Alternative 2. The TWLTL was extended to the west of the project intersection due to the proximity of other driveways in the immediate vicinity of Huntington Drive. It should be noted that only a few hundred feet of TWLTL refuge is needed, and the additional distance of TWLTL shown in Figure 6 is purely concept.

Two improvement alternatives were considered for operational improvements at this intersection. Alternative 1 consists of adding a westbound left turn lane on SR 20/Conyers Road. Alternative 2 consists of adding the westbound left turn lane from Alternative 1, as well as installing a short Two-Way-Left-Turn-Lane (TWLTL) section to the west as a refuge lane for northbound left turning vehicles onto SR 20/Conyers Road. The TWLTL is only needed for the distance that a vehicle would need to accelerate into westbound through traffic. A few hundred feet would be sufficient to provide the required refuge area.
